**PENETROMETER STUDY OF THE MACEDONIA
BAPTIST CHURCH, CHEROKEE COUNTY,
SOUTH CAROLINA**

Prepared By:
Michael Trinkley, Ph.D., RPA

Prepared For:
Macedonia Baptist Church
c/o Mr. James Goforth
849 S. Green River Rd.
Gaffney, SC 29341

February 5, 2007

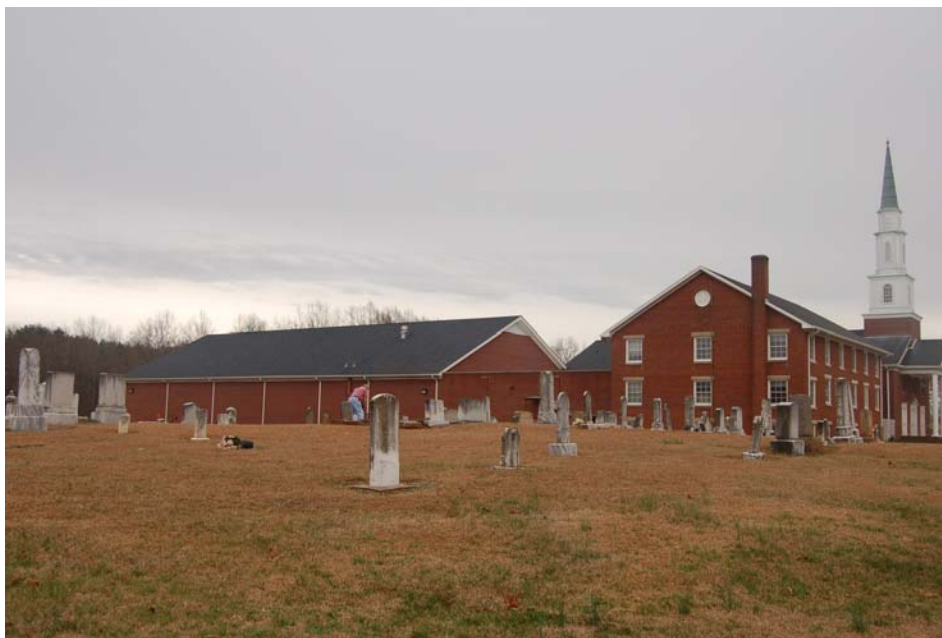
Figure 3. View of the church buildings and cemetery, looking south from the parking area.

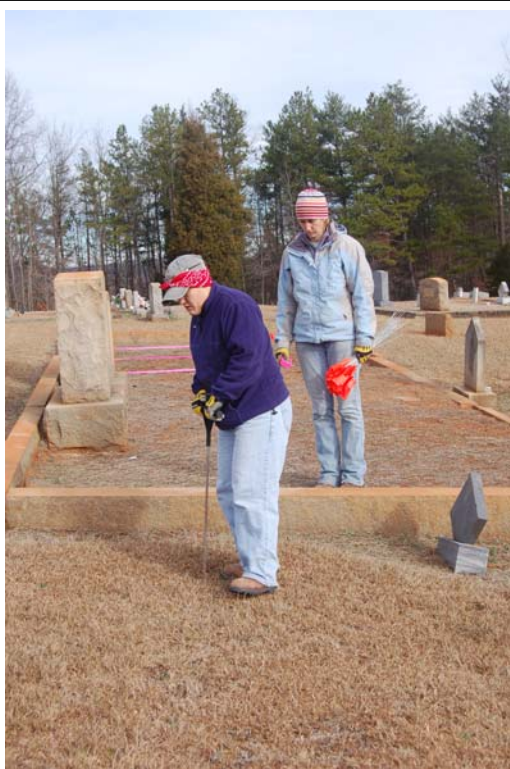
Figure 4. Conducting the penetrometer survey. In the background are three unmarked graves identified by the study that have been flagged.
